# Manhole Inspection Summary

Manhole # S29M1\_009MH

**Inspection** ☐ Is Incomplete Rating: **2) Good**

**Location** Address: **1000 Cherry Hill Road**

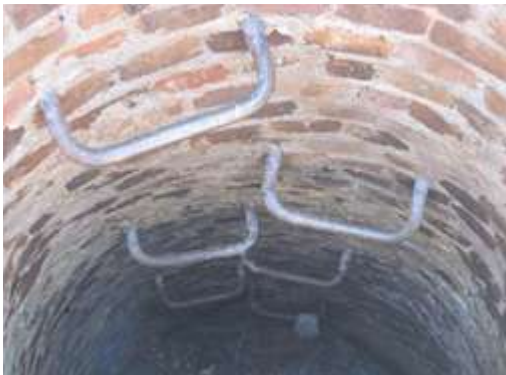
Steps

Count: **8** Missing: **0** ☐ Corroded

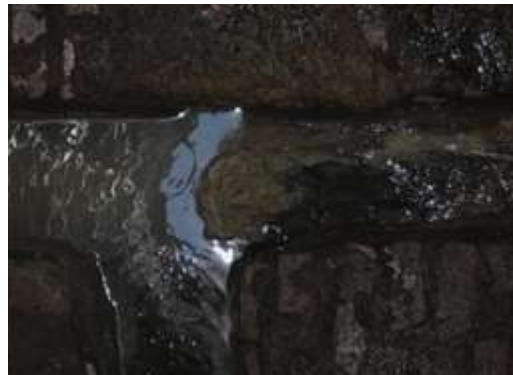
Defect 1

Condition: ☐ Sound ☐ Cracked ☐ Root Intrusion ☐ Deteriorated ☐ Leaks ☒ **Debris**

Channel

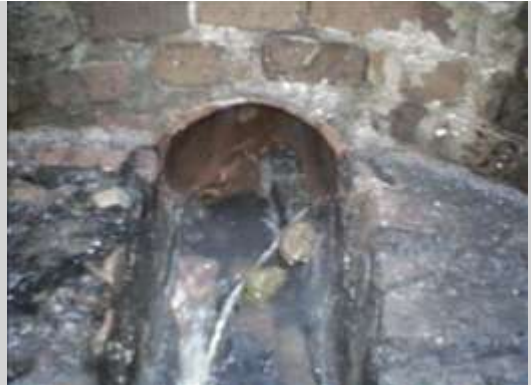
12 O'Clock Outflow

8 in. Circular Gravity Sewer  
Pipe Out @ 12 O'Clock

Pipe Height: **9.6** (in.) Rod and Bar (Angled)  
Pipe Material: **Clay** ☐ Pipe Lined  
Invert Depth: **12.02** (ft.) Flow Characteristics: **Fast**  
Deposits: ☒ None ☐ Mud ☐ Sludge ☐ Debris ☐ Grease  
Silt Depth: (in.) Deposits Extent:  
Infiltration: **None** Pipe Seal Cond: **Sound**

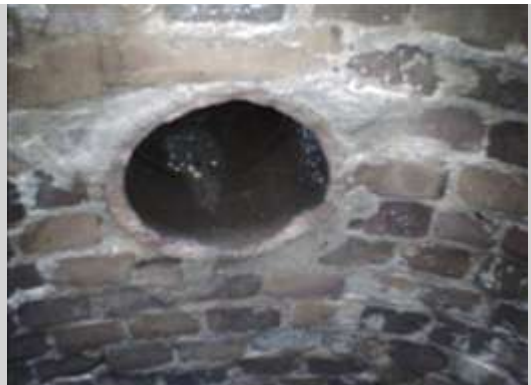
3 O'Clock Inflow

8 in. Circular Gravity Sewer  
Pipe In @ 3 O'Clock

Pipe Height: **9.6** (in.) Rod and Bar (Angled)  
Pipe Material: **Clay** ☐ Pipe Lined  
Invert Depth: **9.80** (ft.) Flow Characteristics: **Fast**  
Deposits: ☒ None ☐ Mud ☐ Sludge ☐ Debris ☐ Grease  
Silt Depth: (in.) Deposits Extent:  
Infiltration: **None** Pipe Seal Cond: **Sound**

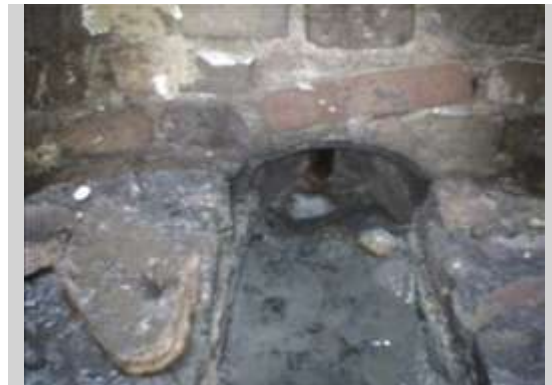
Drop In @ 3 O'Clock

Drop: **Outside** Rod and Bar  
Angled: **Yes** Reading: **10.81** (ft.)  
Inv Depth: **11.81** (ft.)  
Drop Condition: **Open**

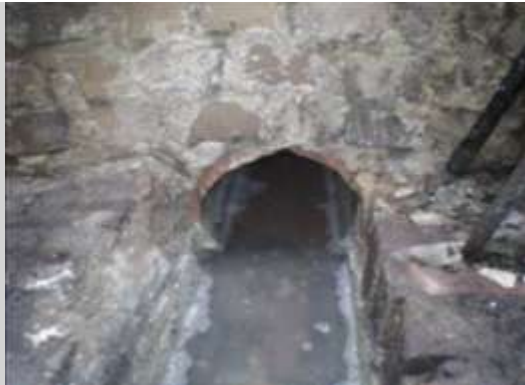
6 O'Clock Inflow

Pipe In @ 6 O'Clock

Infiltration: **None** Pipe Seal Cond: **Cracked**
